Sand Dollar IV Condominium

Saint Augustine, Florida

Facility Inspection Survey Report and Results

MAY 2024

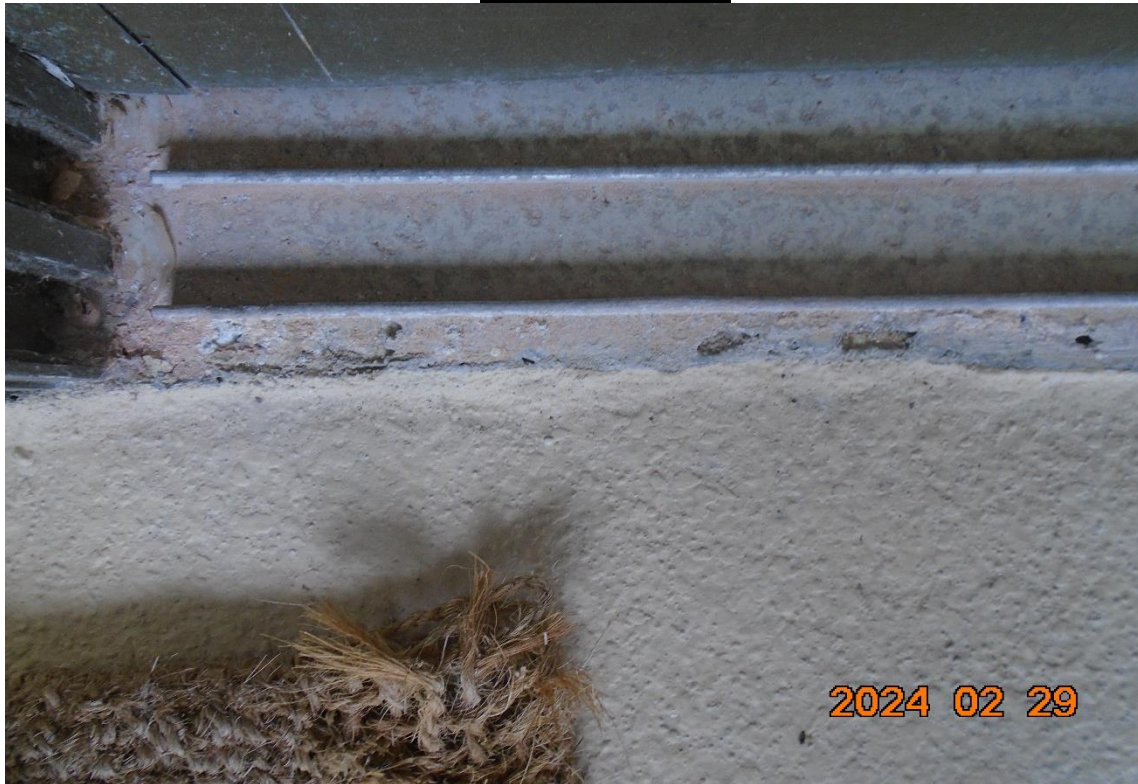
Several original construction sliding glass doors have holes oxidized through the threshold, which are 207, 306, 403, 501 and 504, creating a water intrusion source and should be replaced.

Figure 1. 306 sliding glass door threshold oxidized condition replacement is required to mitigate the water intrusion.

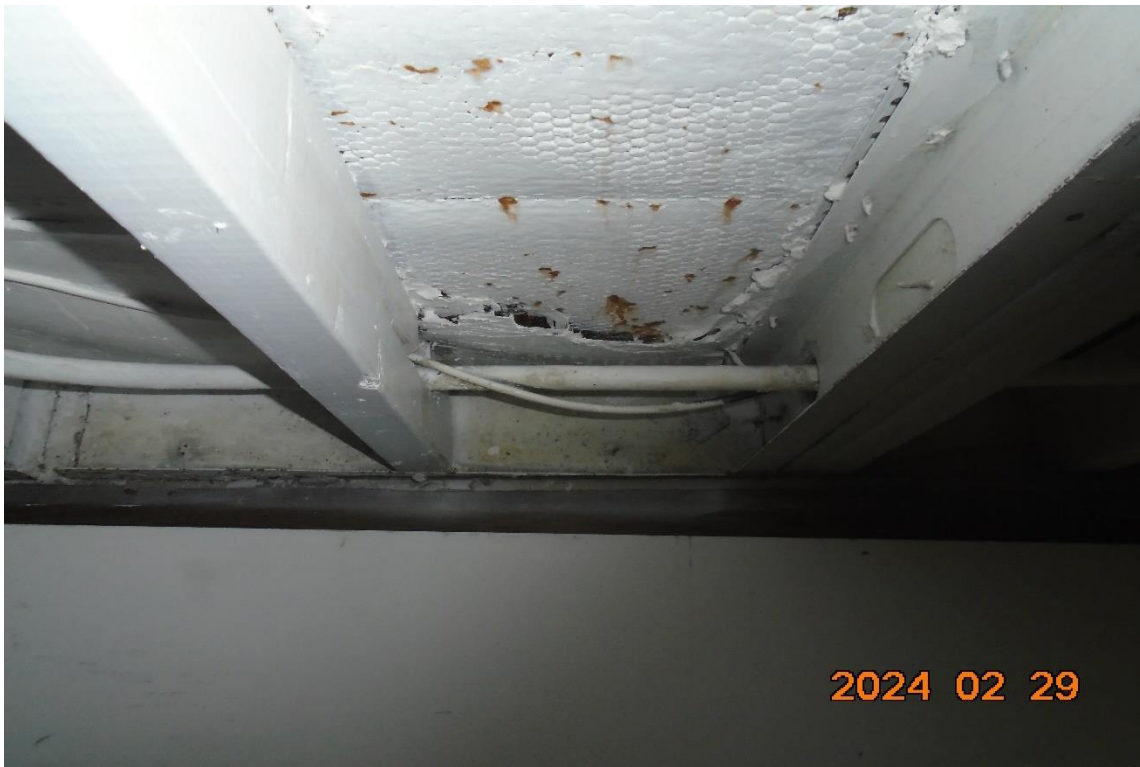
although the light gauge steel framing at the slab was severely corroded requiring bottom channel and some stud replacement. All envelope static cracks will be treated and sealed with elastomeric patching compounds and if dynamic in nature will be routed-and-sealed with a polyurethane sealant. The planned paint system will incorporate a conditioner and one finish coat of 100% acrylic with a satin sheen for added self-rinsing qualities to achieve a standard Sherwin Williams 7-year standard warranty.

Figure 2. 202 living room east wall severely corroded framing and metal lath condition.

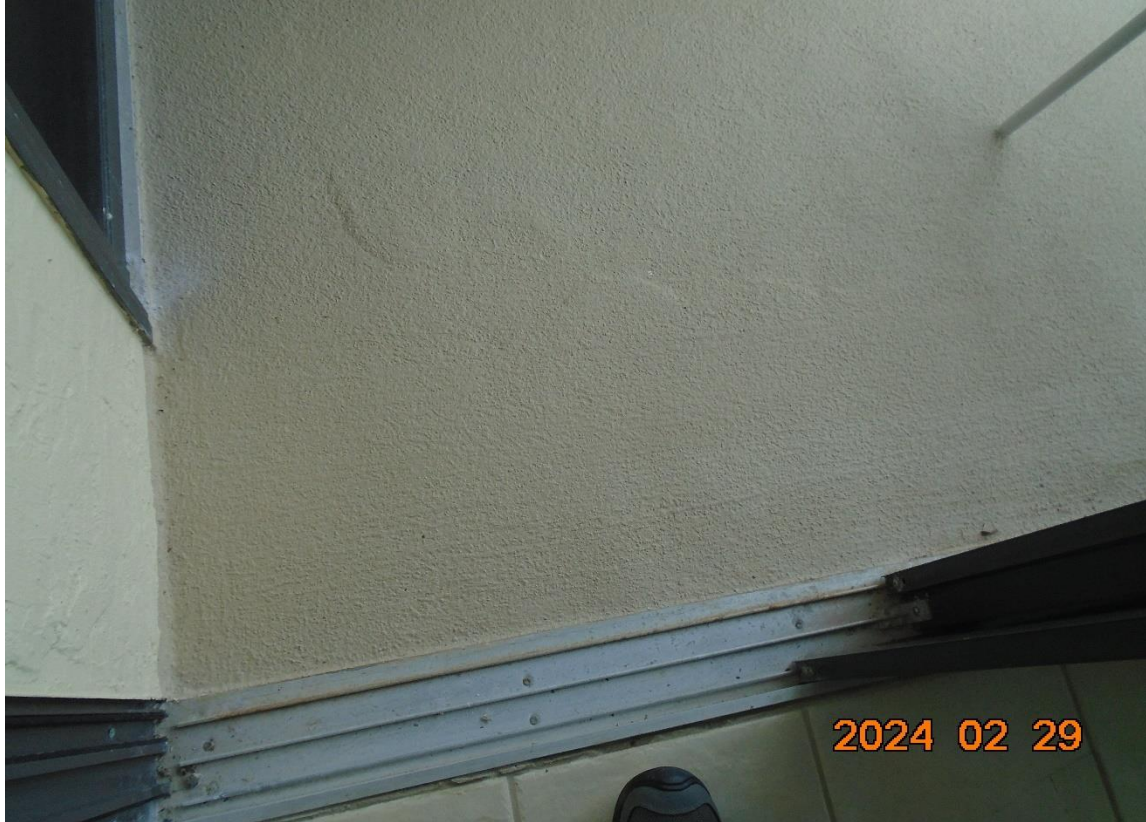
Figure 3. Example of a surface spall at 501 balcony.

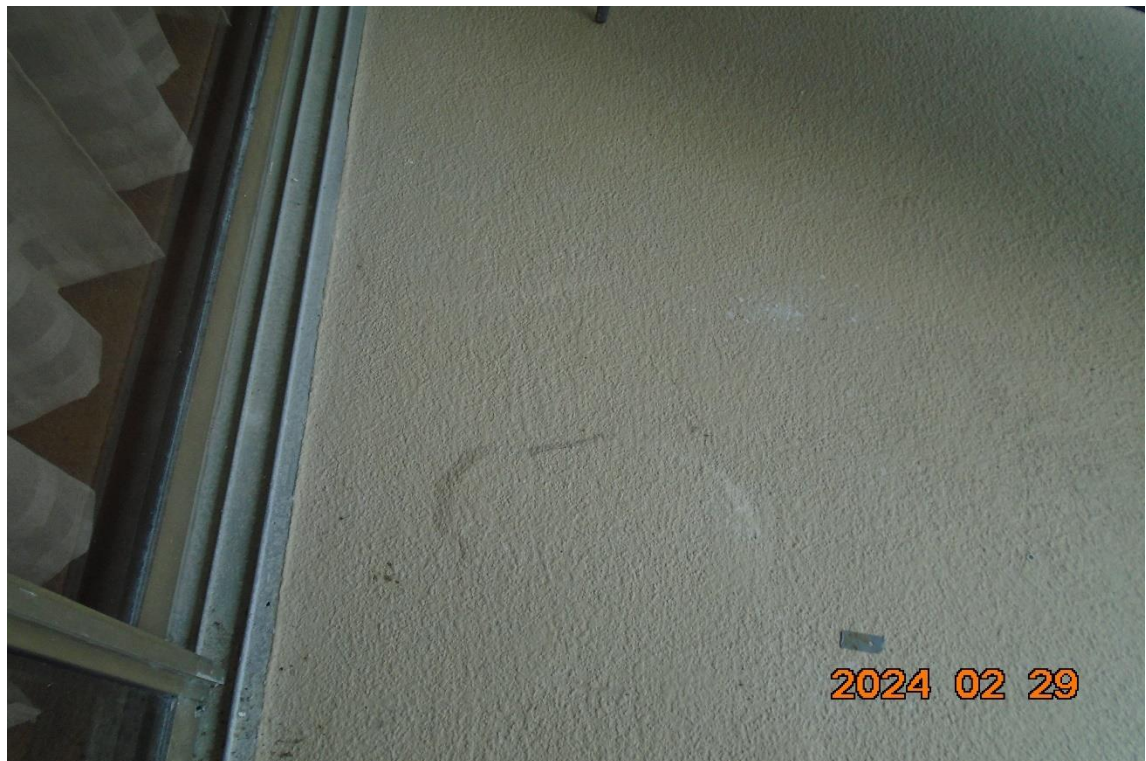
Figure 4. 504 balcony surface spall.

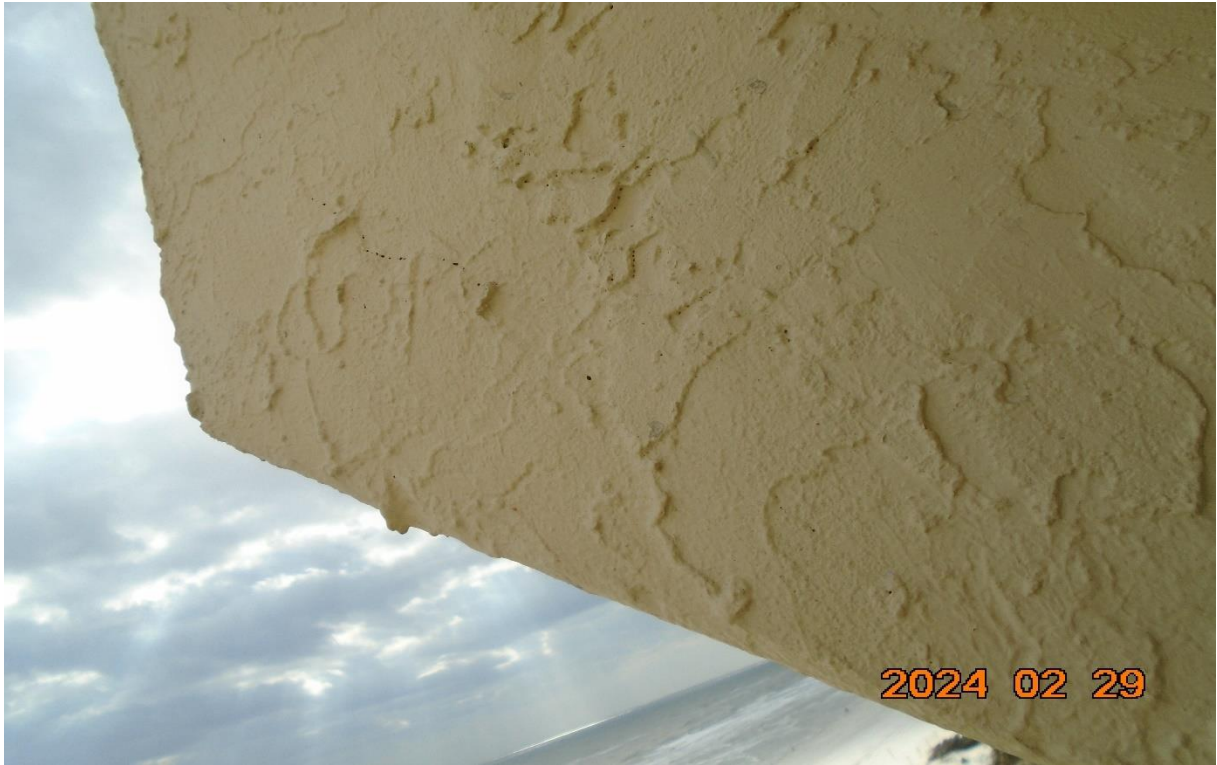
Figure 5. Roof parapet spall above 505 balcony.

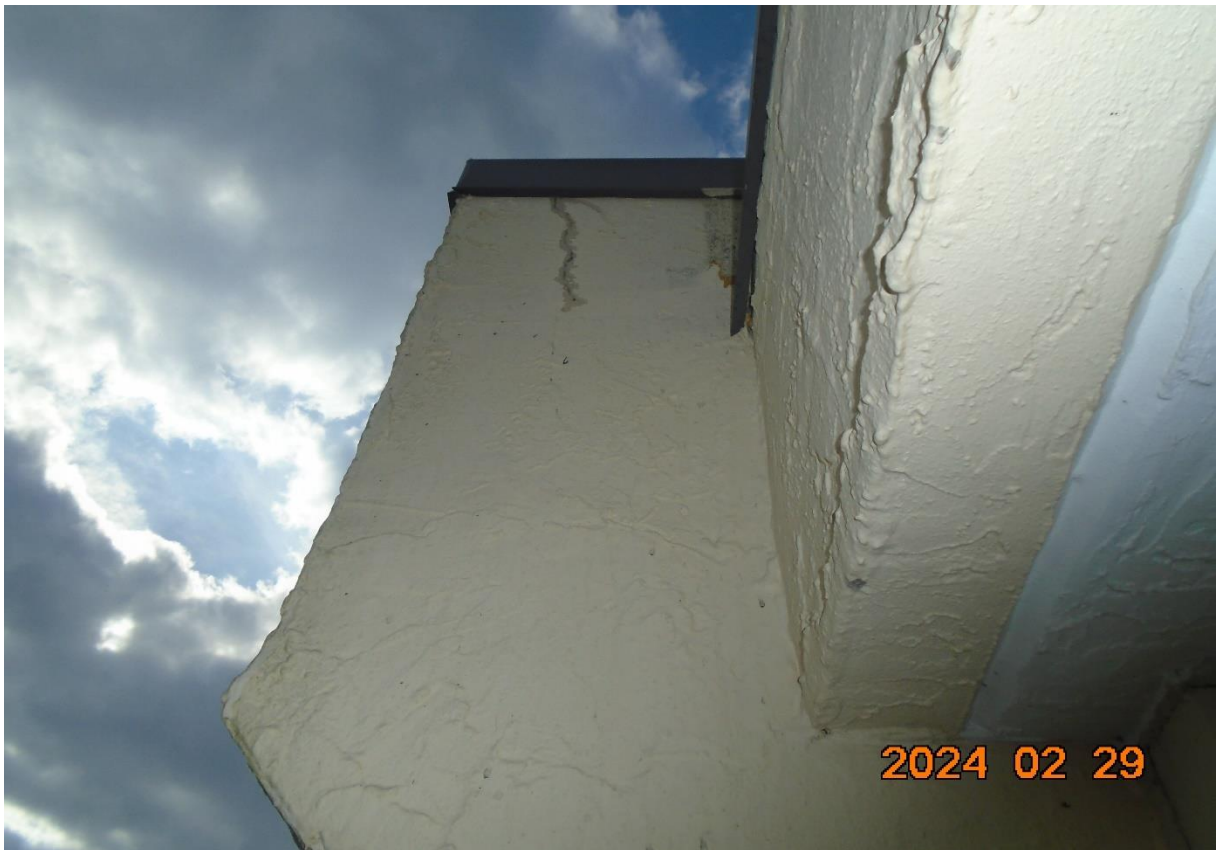
Figure 6. Parapet spall where coping cap may be impacted. `

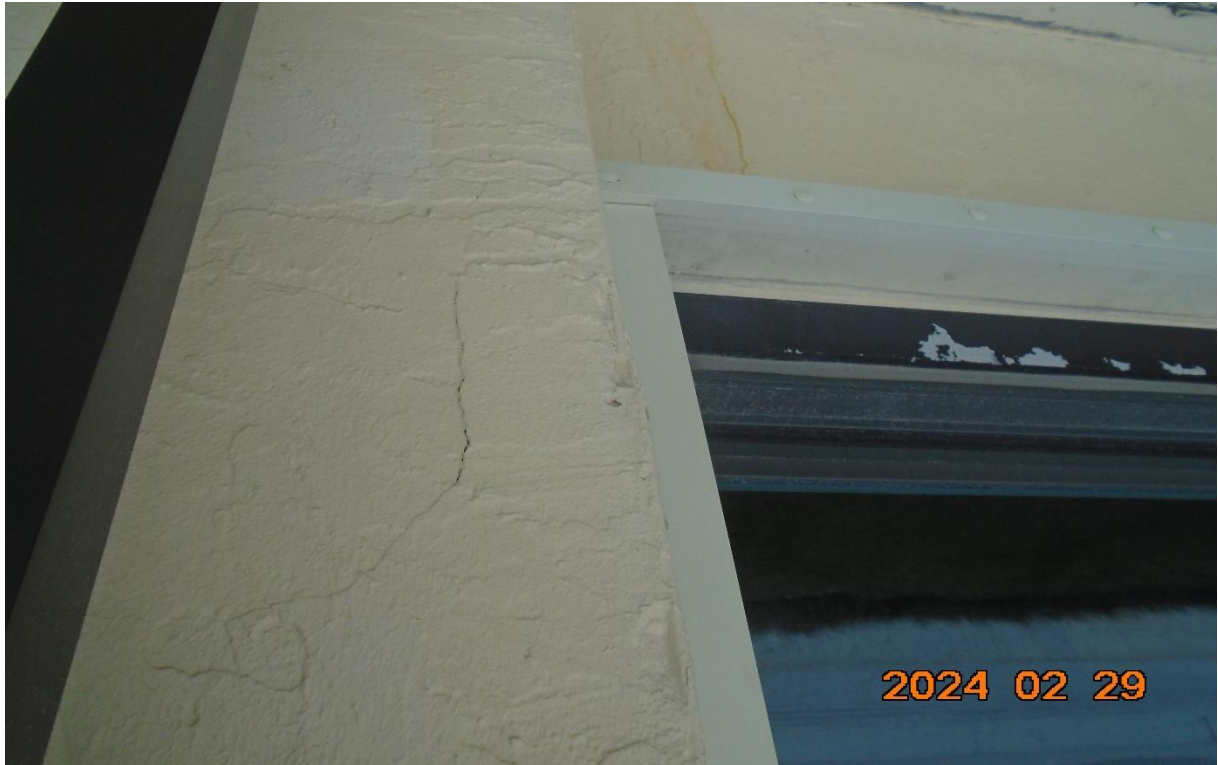
Figure 7. Example of a column spall outside 302 balcony.

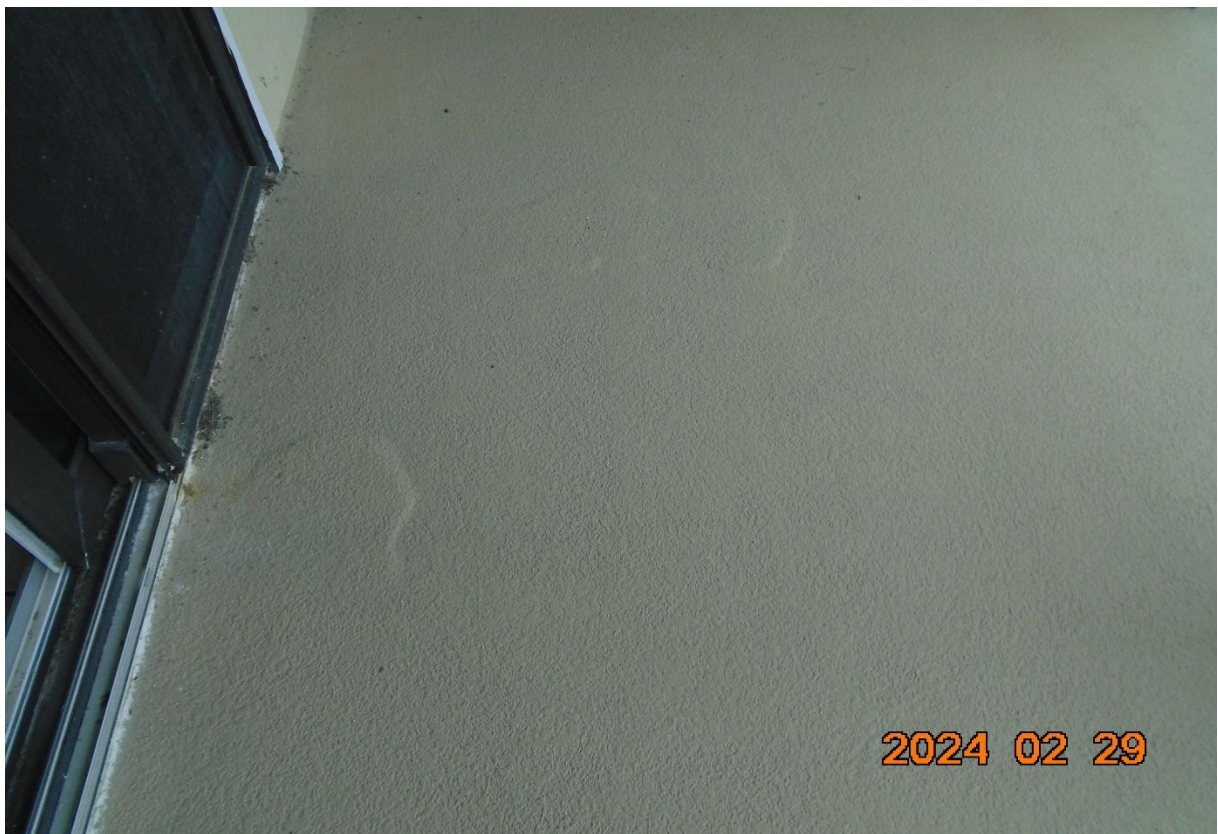
Figure 8. 208 several surface spalls.

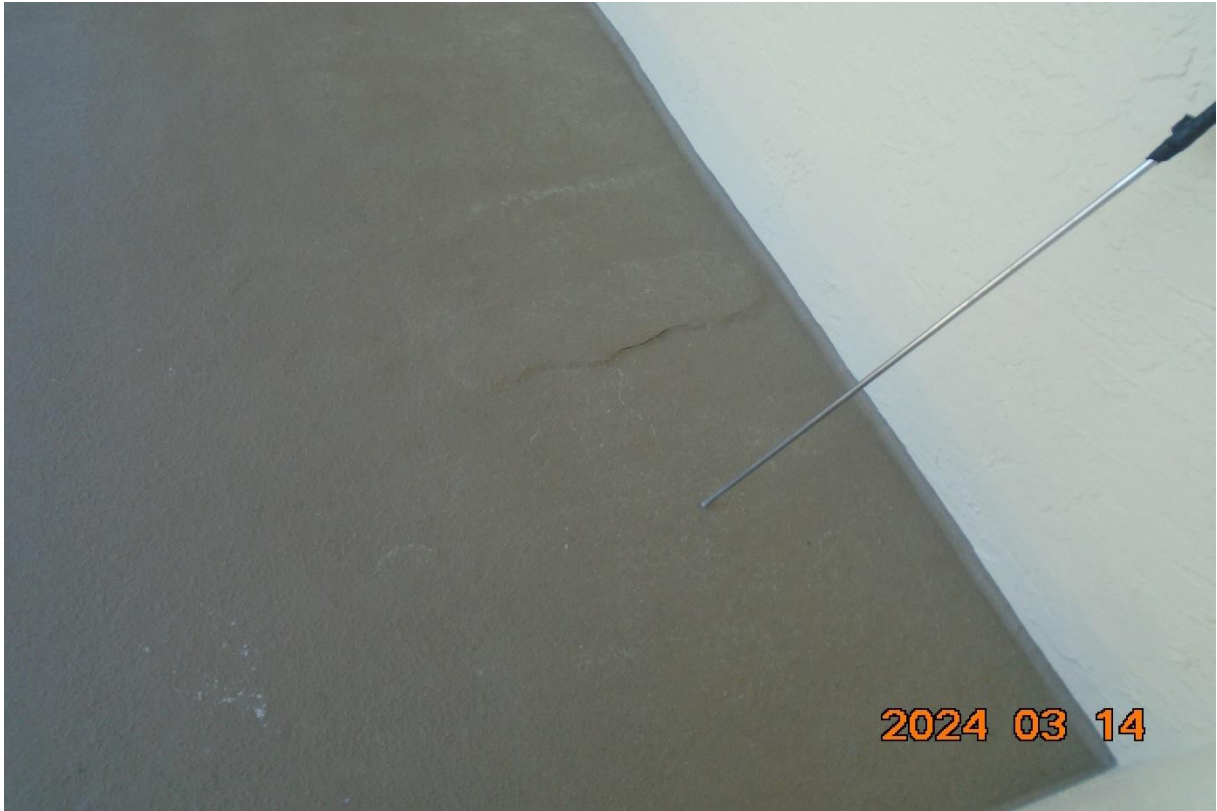
Figure 9. Surface spall at walkway 207.

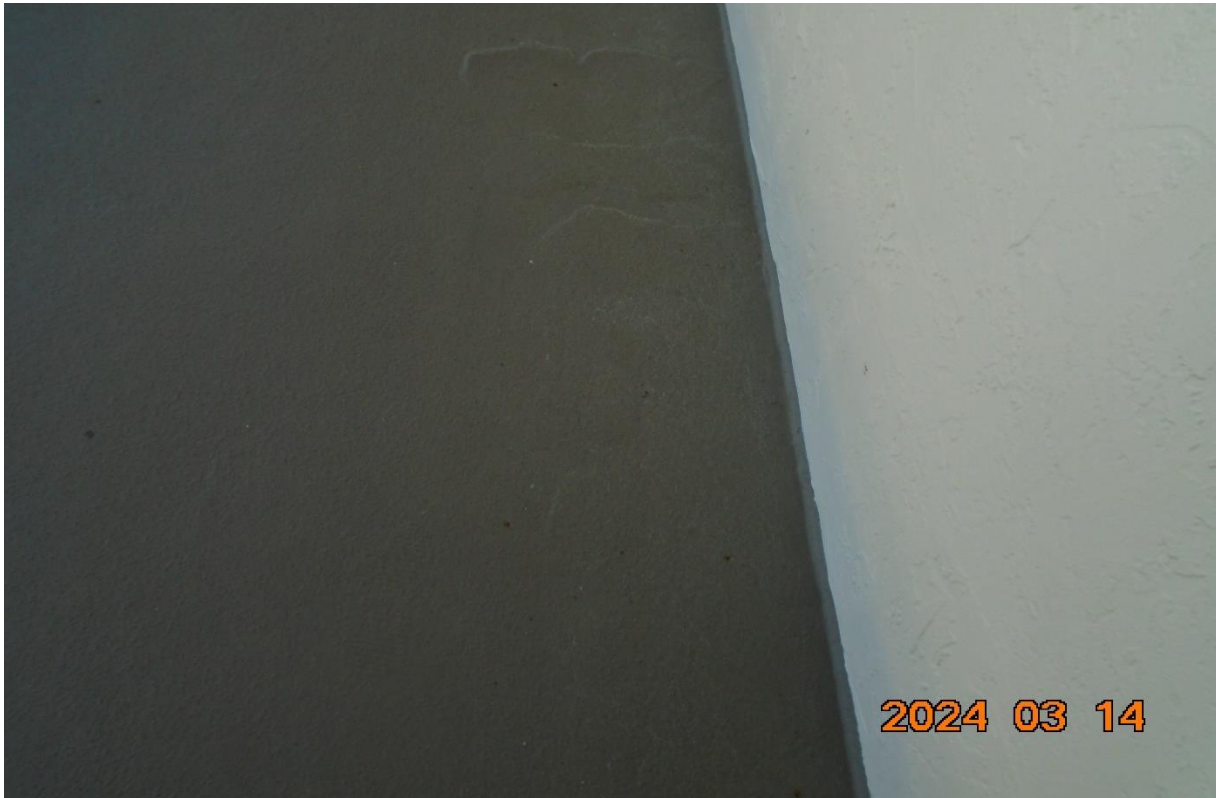
Figure 10. Multiple spalls at 204 walkway area.

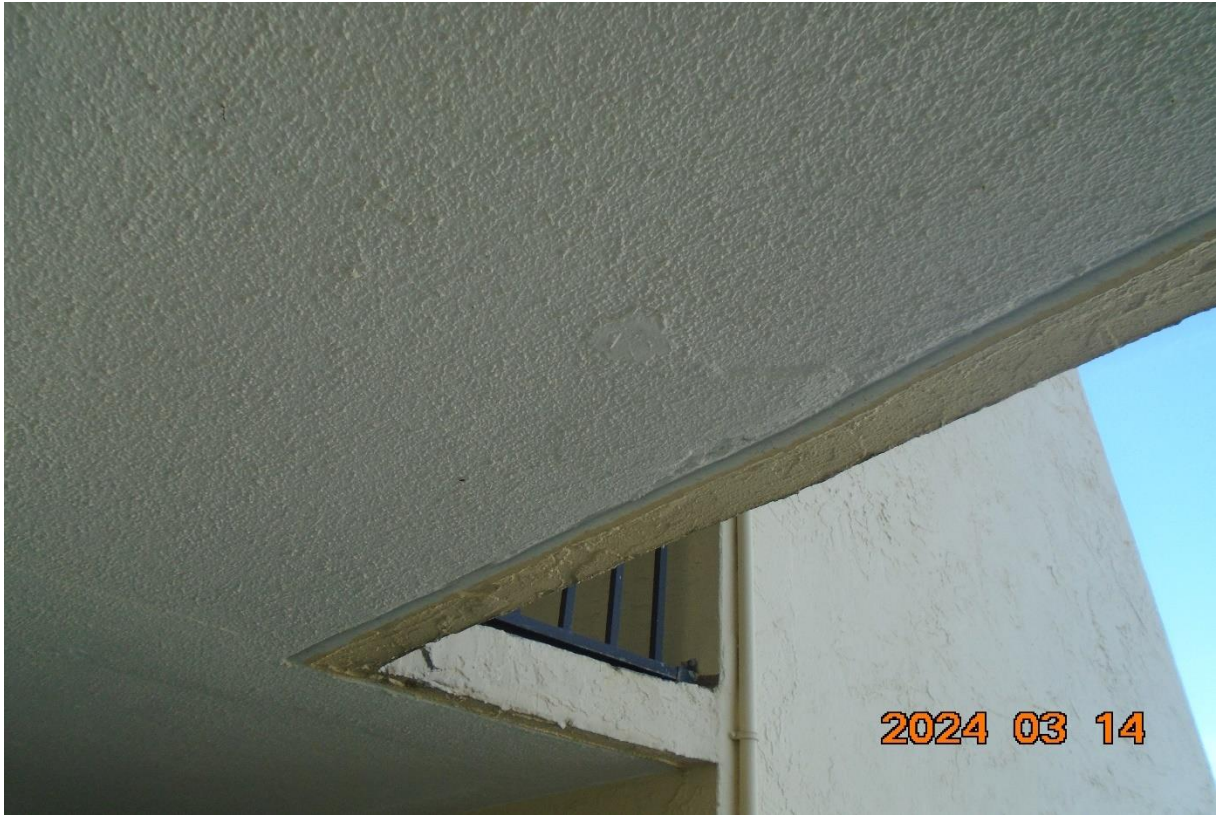
Figure 11. Edge spall overhead outside 204 entry door.

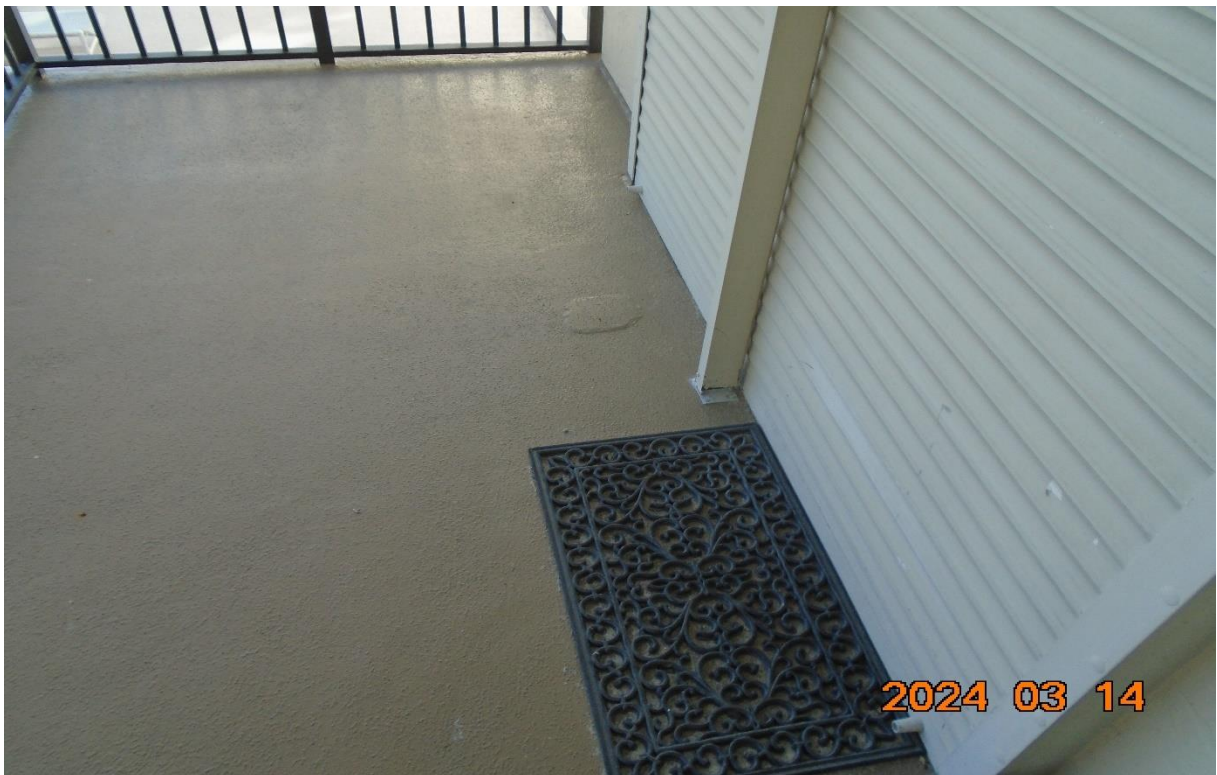
Figure 12. Unit 201 walkway balcony surface spall.

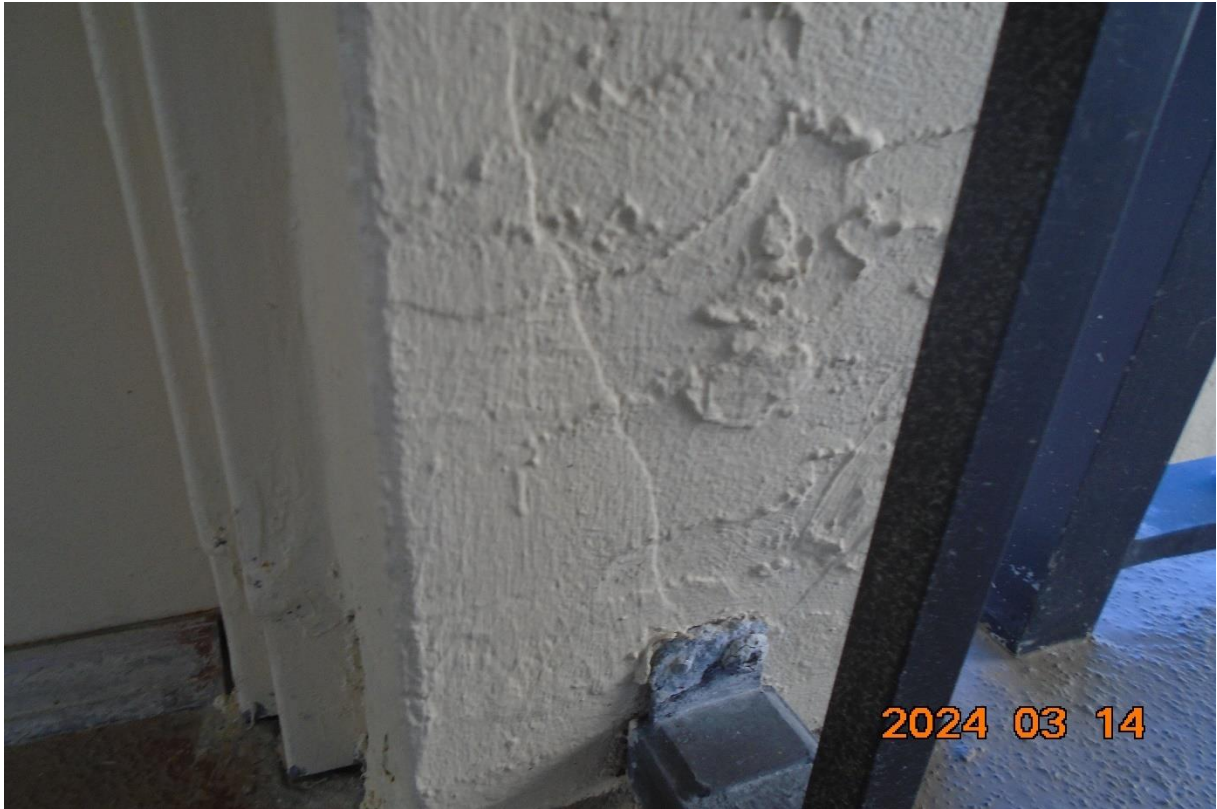
Figure 13. 2nd floor north stairwell door jamb spall and rail receptor anchor failed from oxidation.

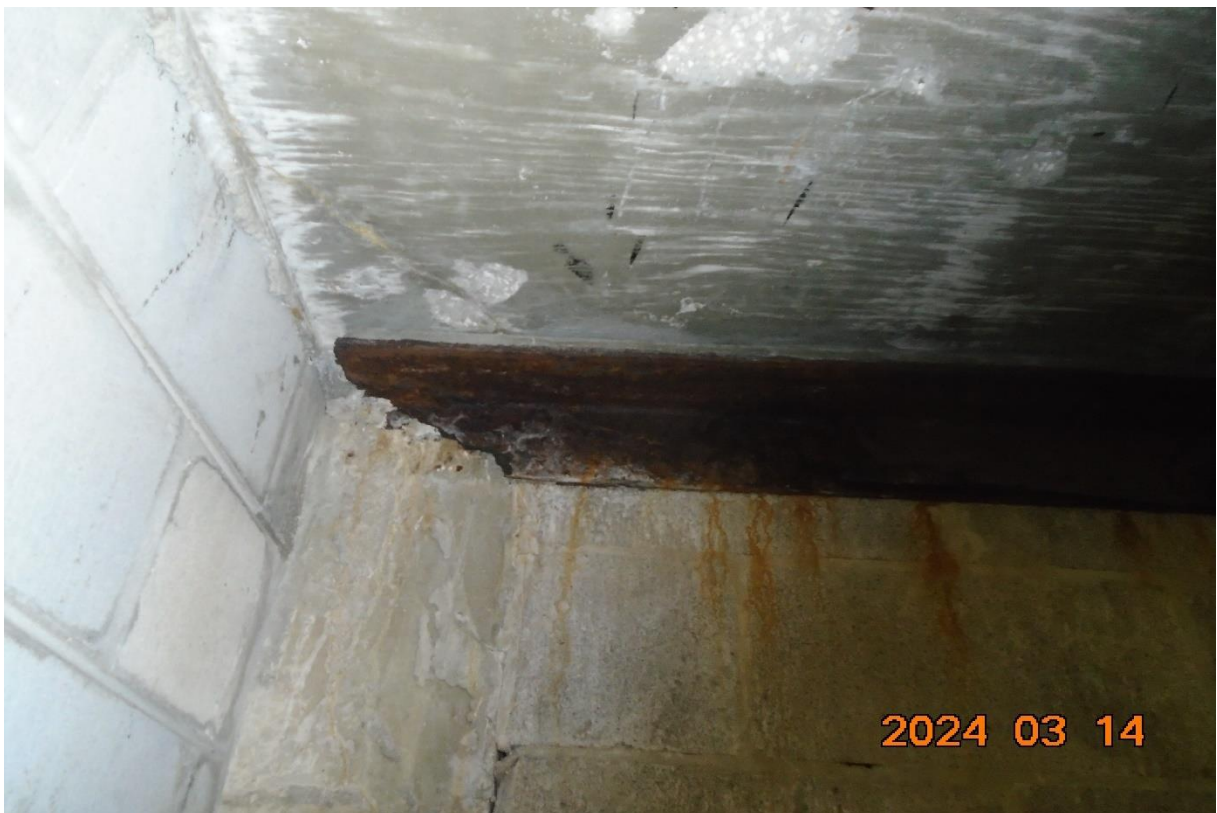
Figure 14. Generator room ledger angle corroded to failure.

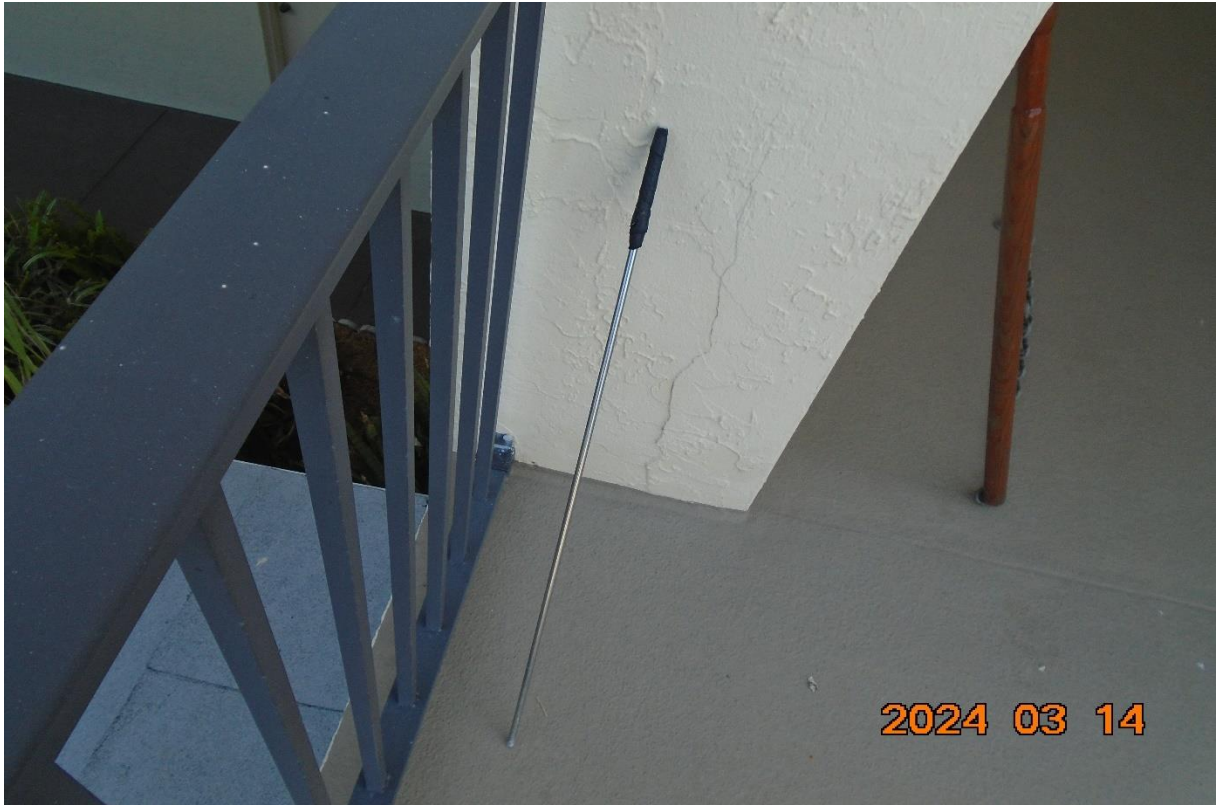
Figure 15. Column spall 2nd floor elevator landing.

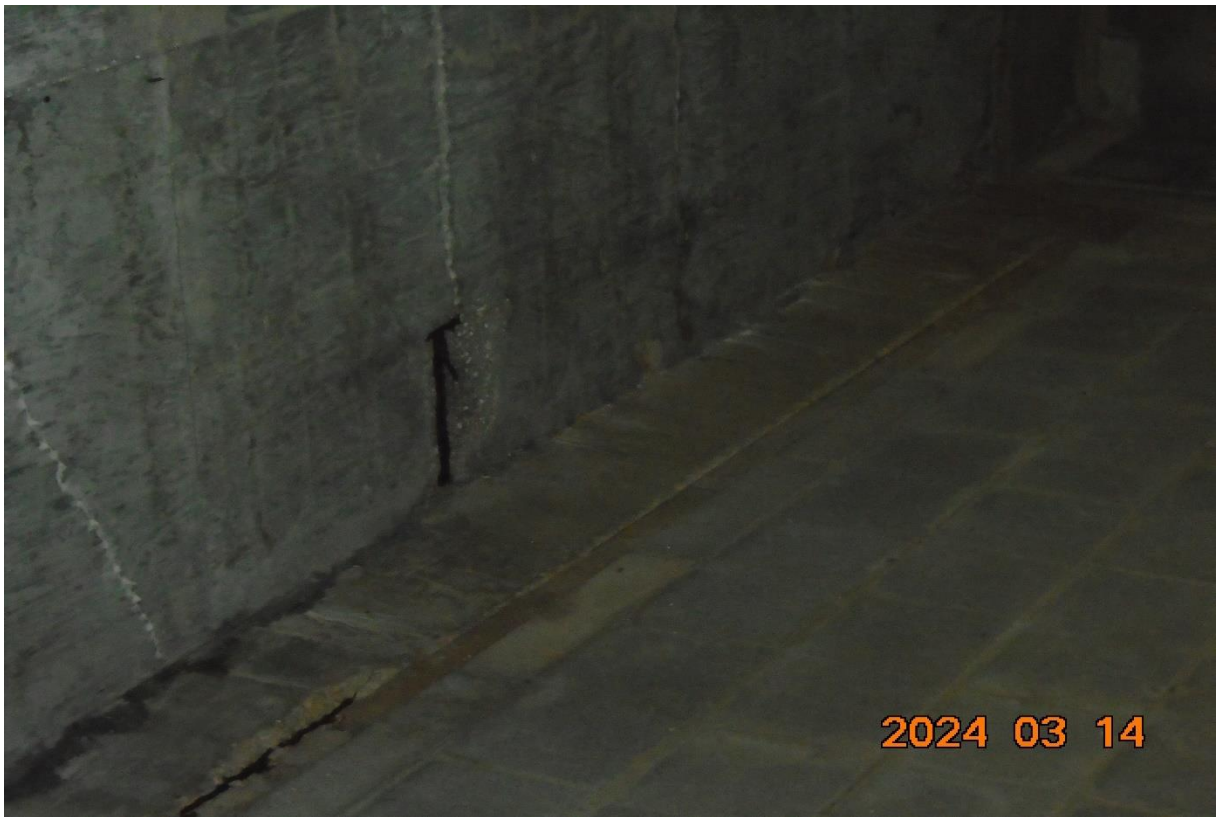
FLP Vault - The room was found unsecured and from the doorway a couple of spalls were discovered that are small, but coordination with the utility company will be required in advance to gain a safe work area.

Figure 16. Ceiling spall inside FPL vault.

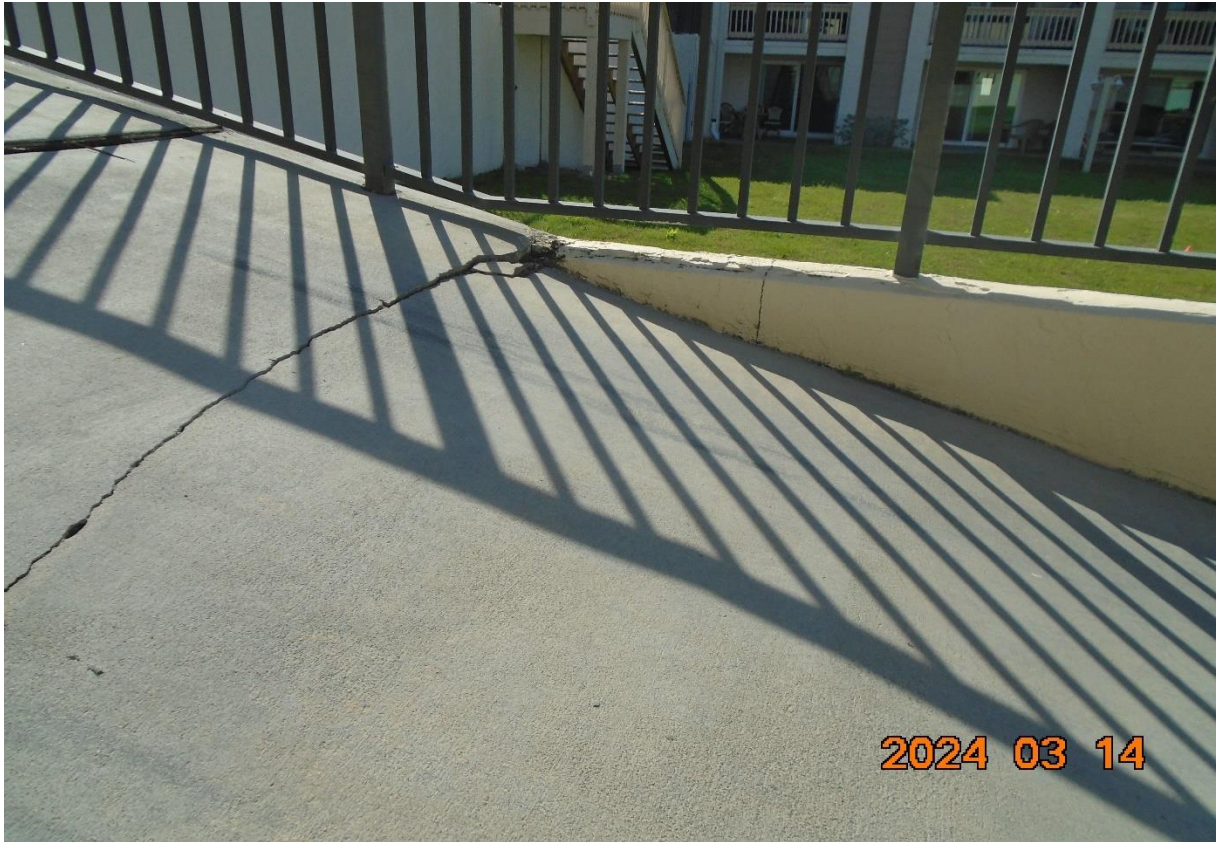
Figure 177. South elevation service ramp erosion and deflection with masonry cracking in walls.

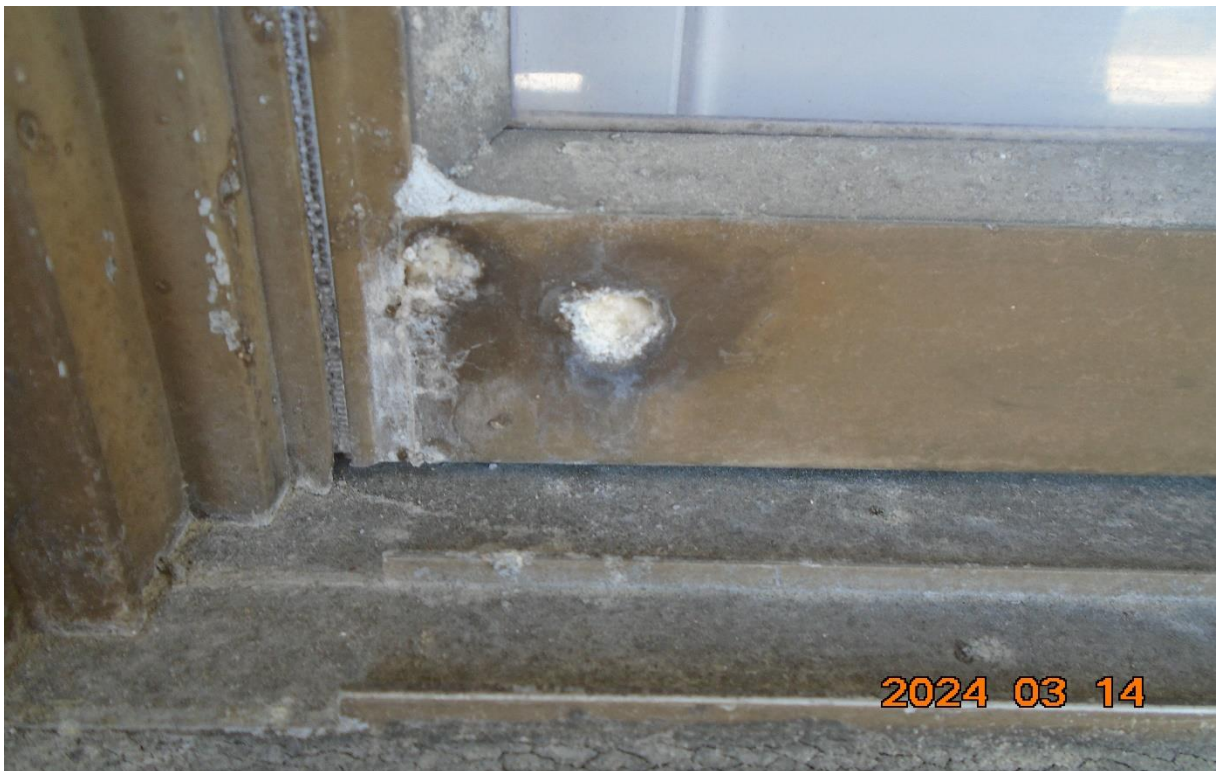
Figure 18. 103 walkway window reached useful life of structural connections.

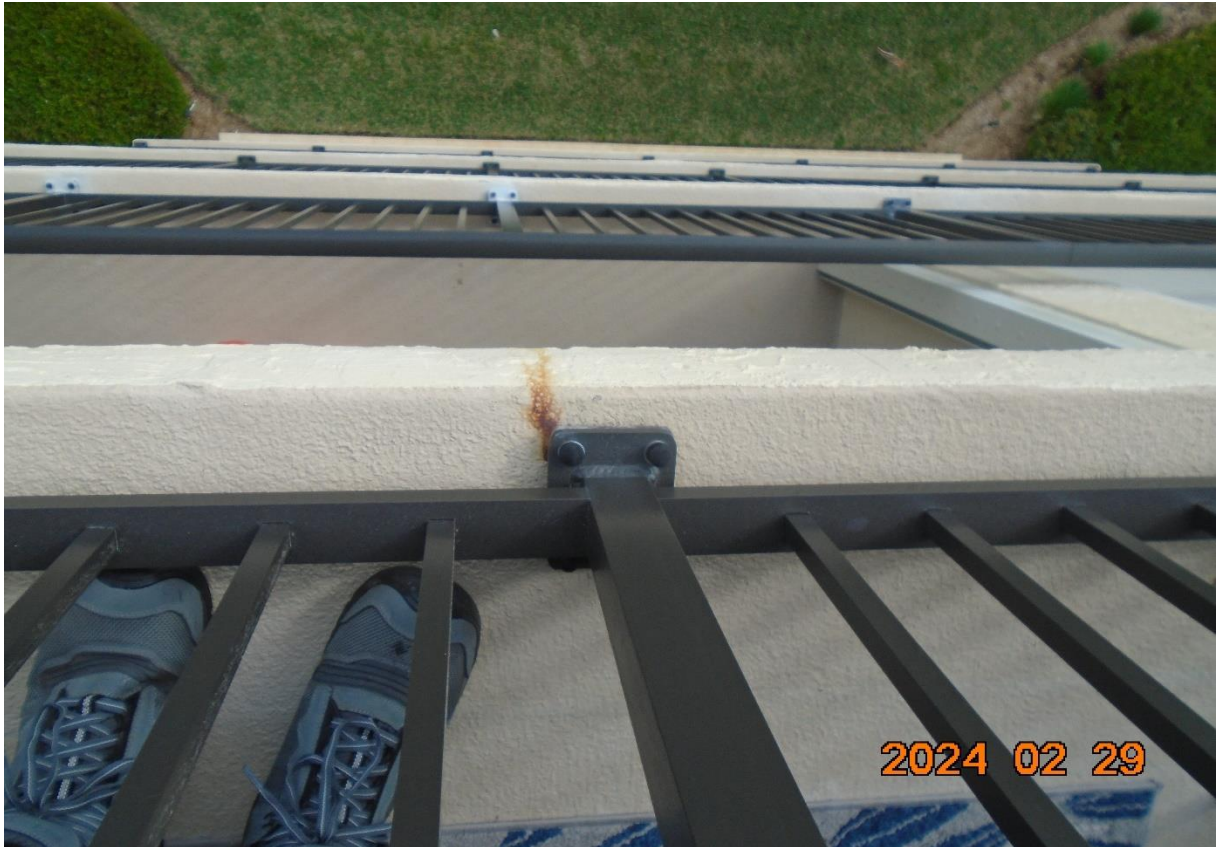
Figure 189. Example of a corroding anchor to be replaced under miscellaneous fastener Line Item of the budget.

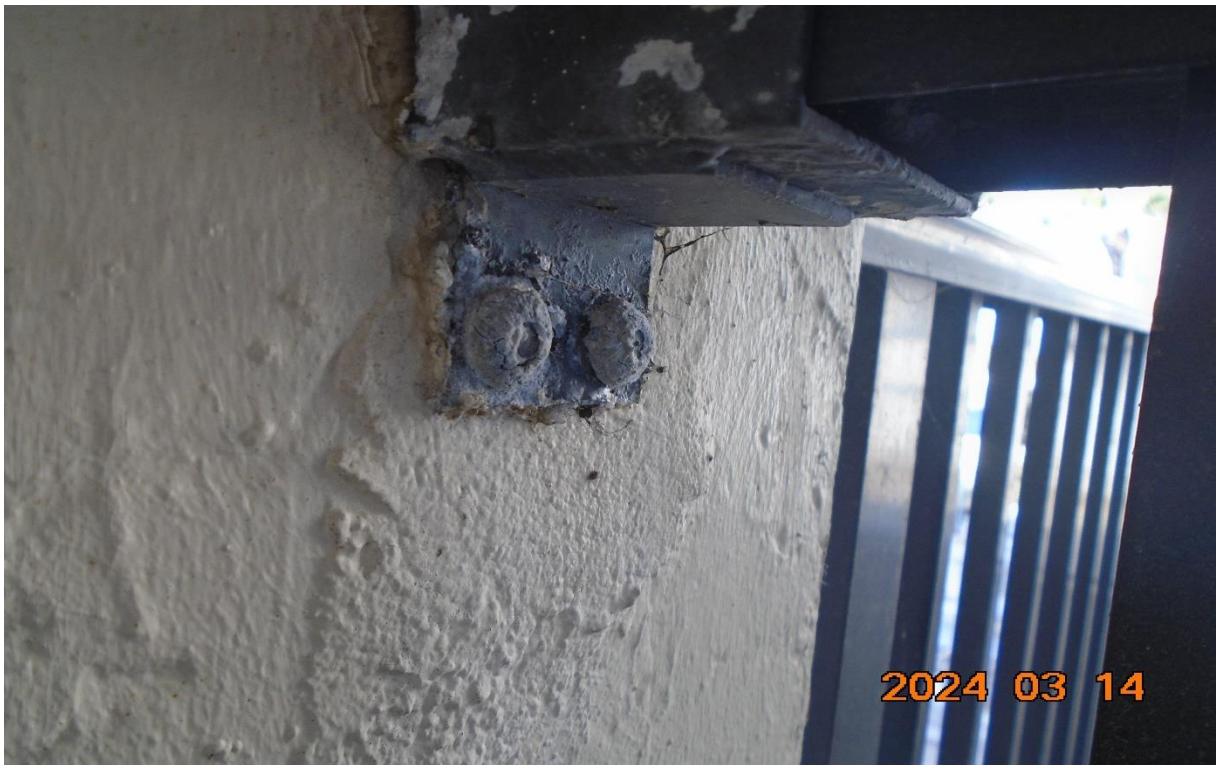
Walkway railings, although serviceable, have advanced oxidation at some areas of the top and bottom member receptor fasteners located at the terminal ends that have caused stucco delamination and cracking. The recommendation and budget reflects keeping the rails in-service and addressing the deficient fasteners on an as-needed approach with the cost assigned to miscellaneous fasteners and or the guard rail allowance.

Figure 20. Example of oxidizing aluminum fasteners at walkway railing wall receptors.

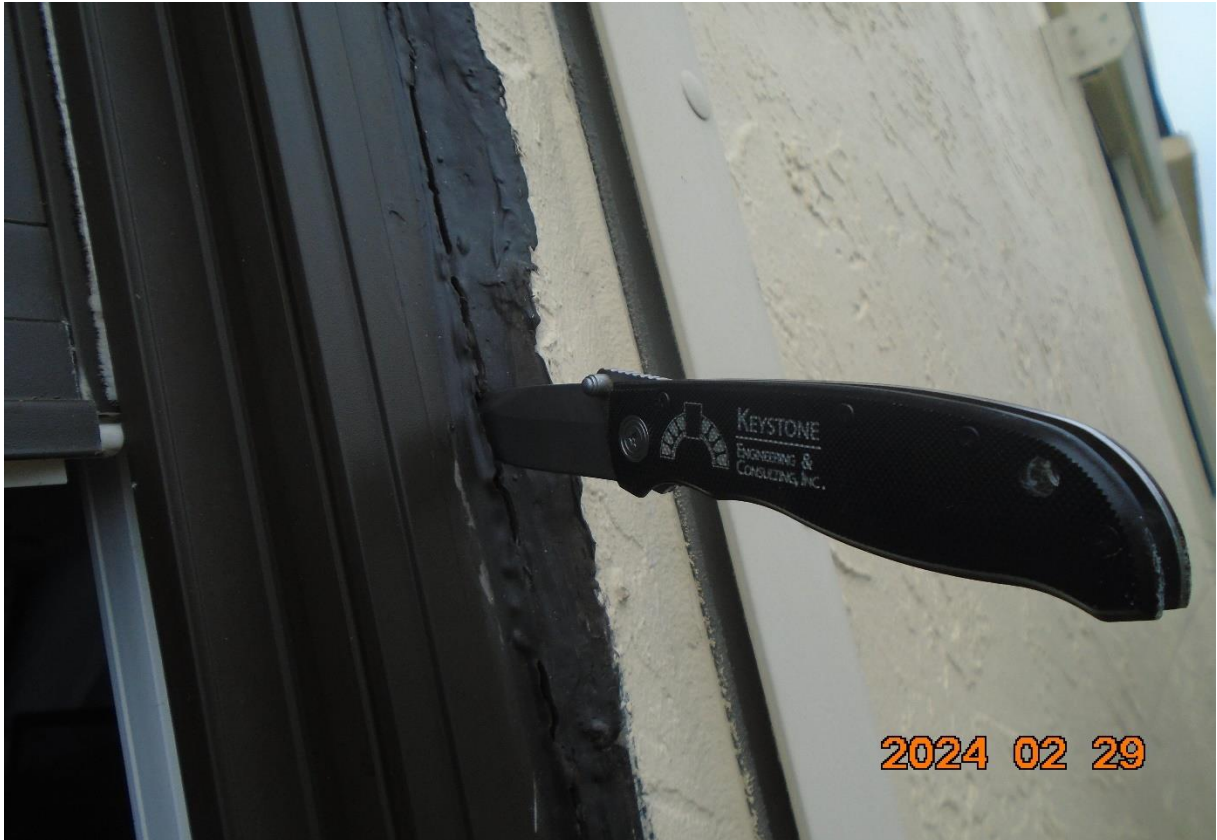
Unsealed envelope penetrations, for example light fixtures and receptacle boxes, and should be replaced or sealed to achieve a weathertight condition.

Figure 21. Example of many witnessed unsealed window and door assemblies.

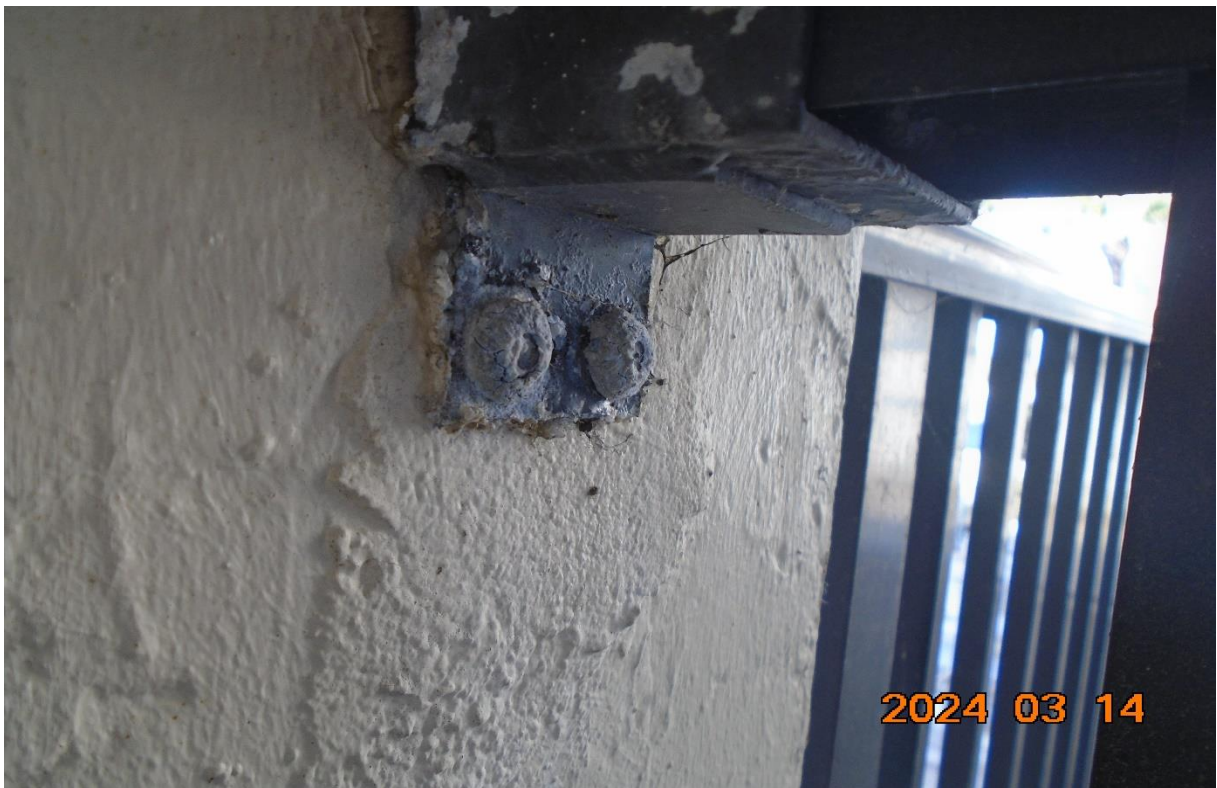
Figure 22. Example of oxidizing aluminum fasteners at walkway railing wall receptors.

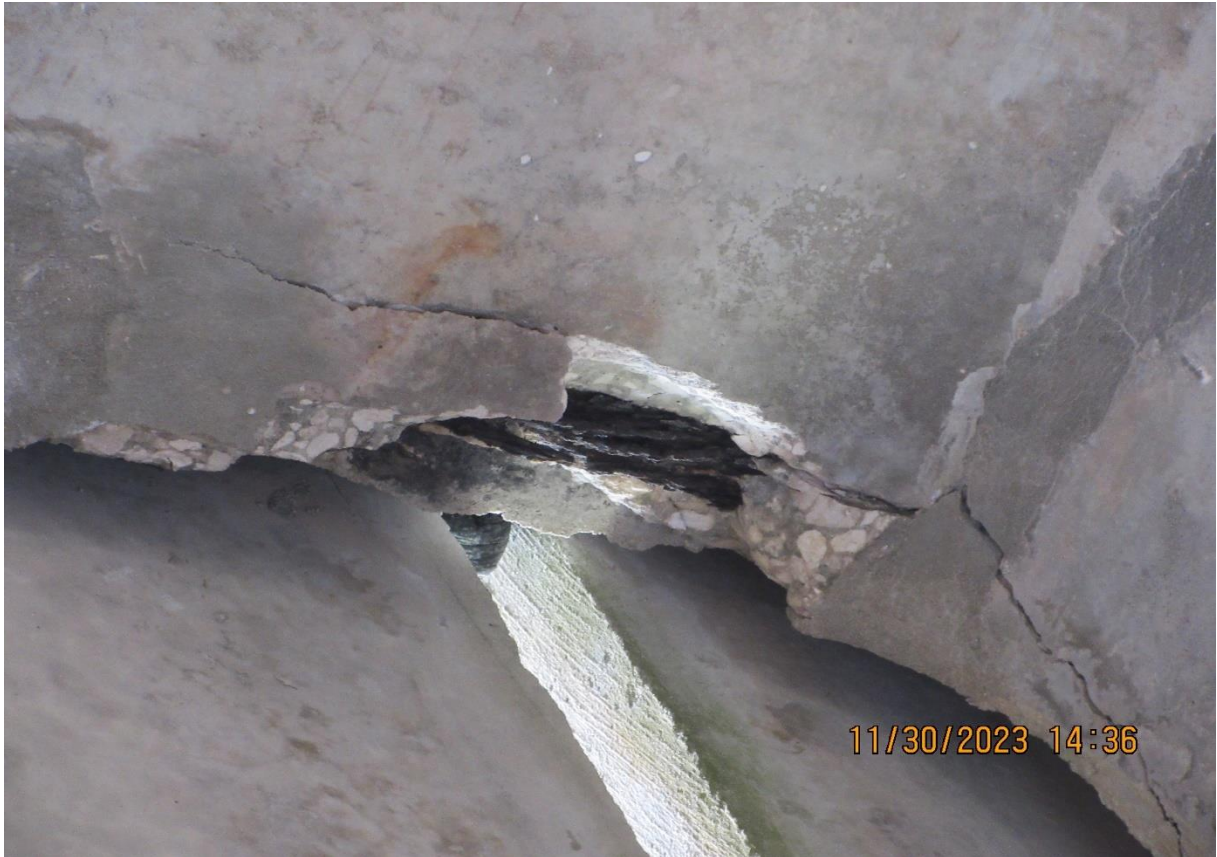
Horizontal reinforcement in the top plate of the tee is exhibiting corrosion symptoms primarily at the perimeters as expected due to the increased exposure to chlorides and the weld plates embedded at the sides of each tee have local spalling that is expected after decades in service. The areas should be visually inspected on a quarterly frequency and remove any delaminated sections found before it dislodges and harms person or property. Topical treatment with an epoxy to encapsulate the accessible areas, for example Sherwin Williams Macropoxy, should be performed after mechanically removing all scale.

Figure 23. Example of double tee plate spall in garage.
