Sand Dollar IV Condominium

Saint Augustine, Florida

Facility Inspection Survey Report and Results

MAY 2024

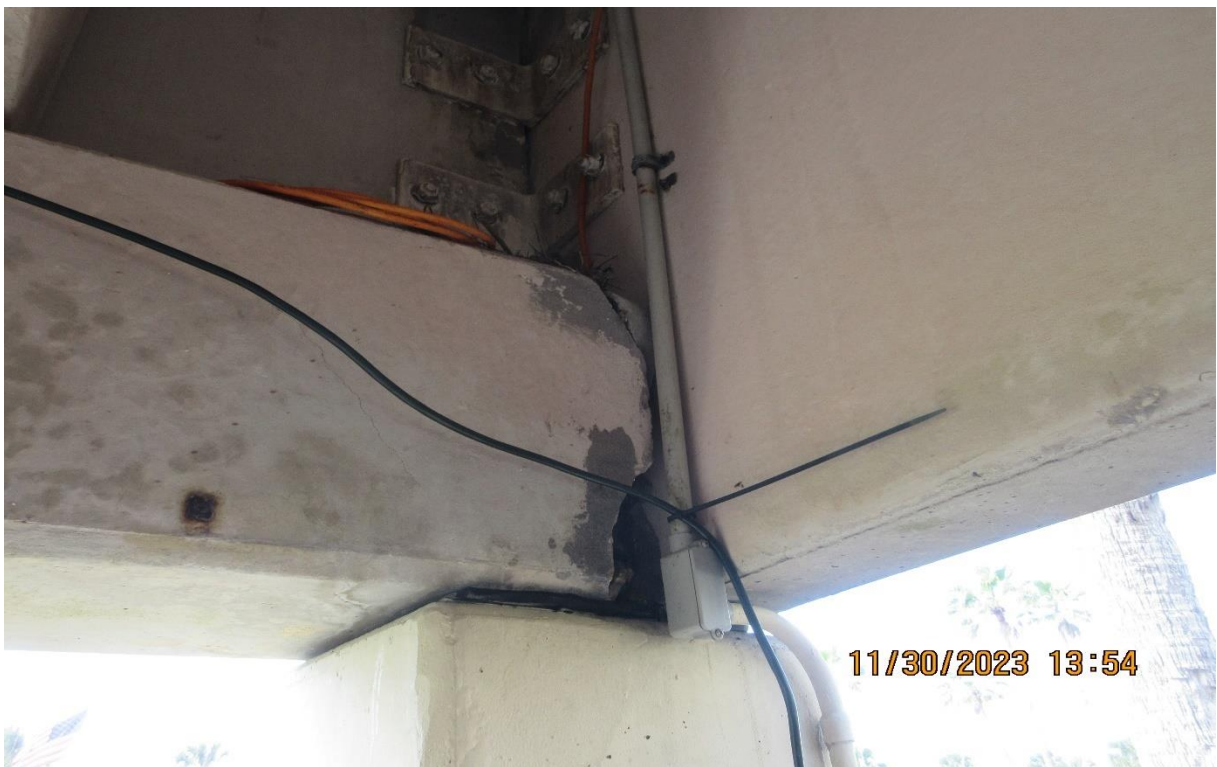
Figure 24. Example of garage perimeter beam end spall.

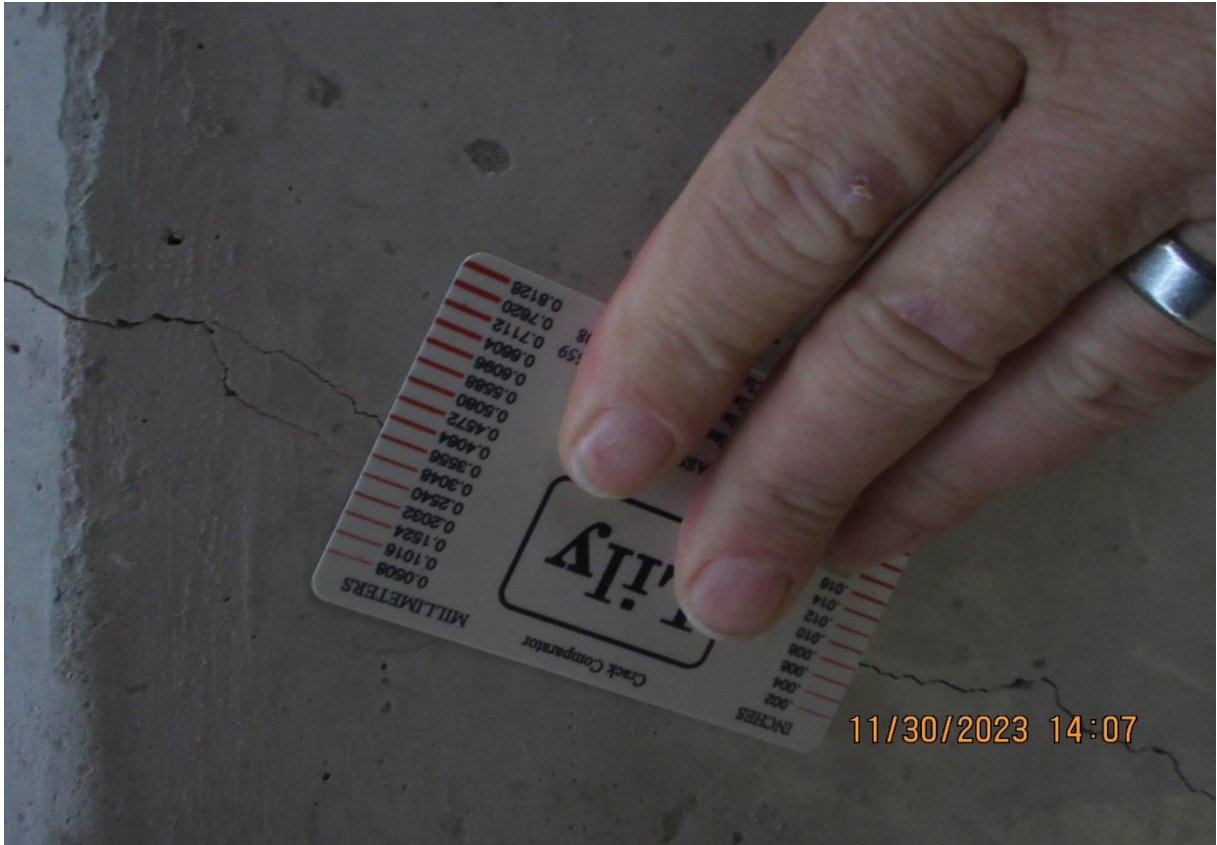
Diagonal cracking exists in the precast soffit beams at the perimeters averaging about 0.006 of an inch diameter with no shoulder deflected or displaced. The cracks should be inspected by a

Figure 25. Example of garage perimeter beam cracks evaluated for diameter.

competent party semiannually and any noticeable changes in diameter of plane at the cracks an engineer should be contacted to review.

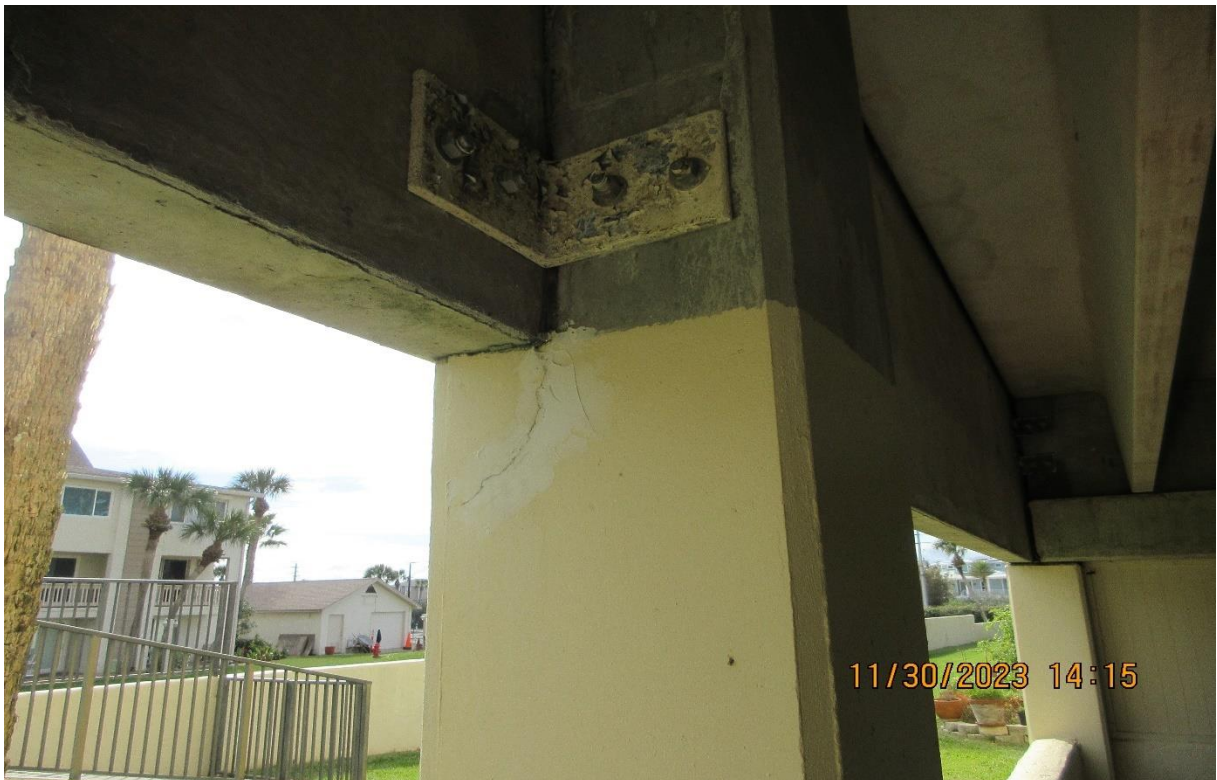
Figure 26. Column spall at south end of the garage.

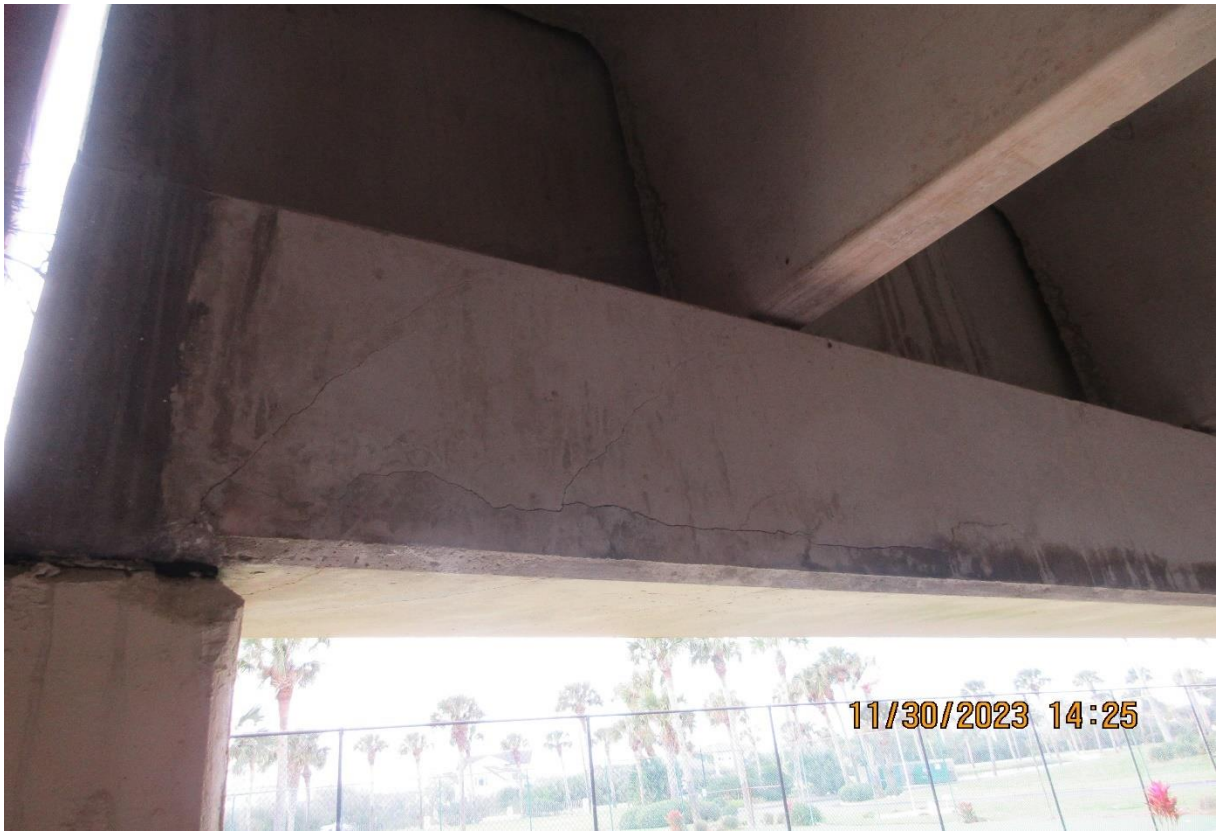
Figure 27. Garage west elevation perimeter beam spalled.

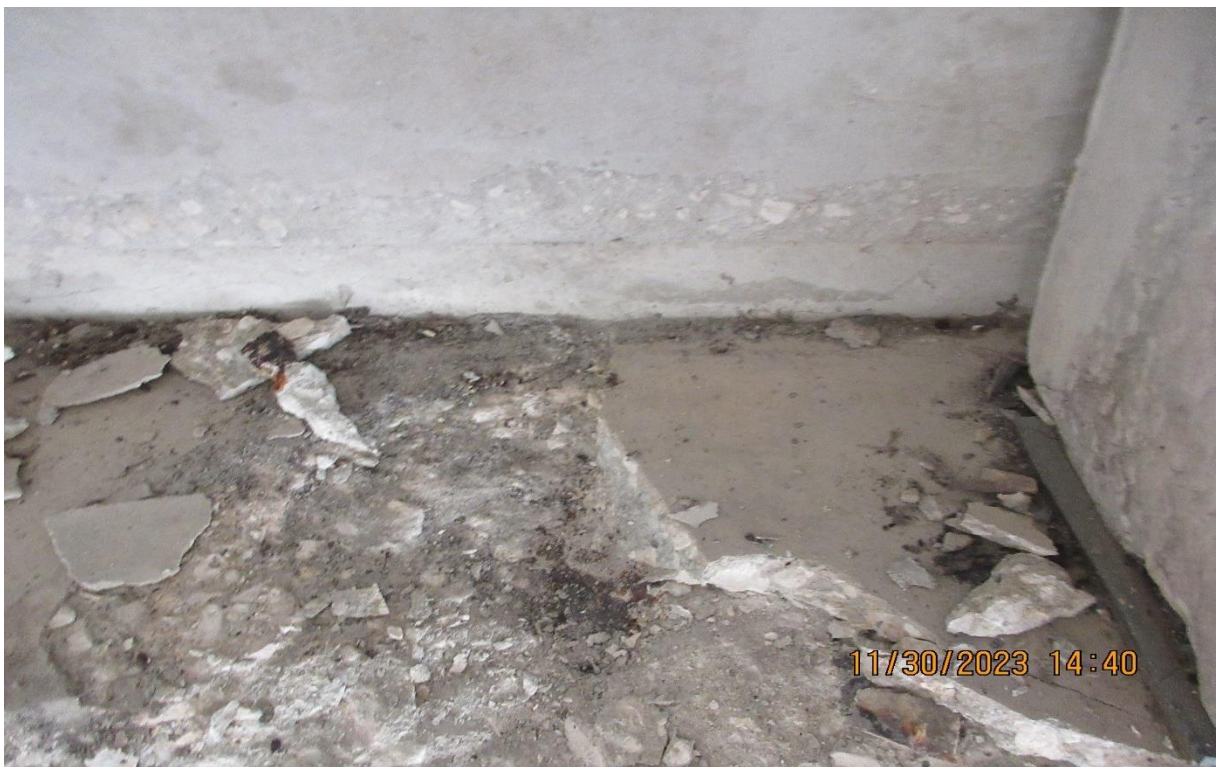
Figure 28. Spall was discovered at the top of the garage beam near the tee bearing point.

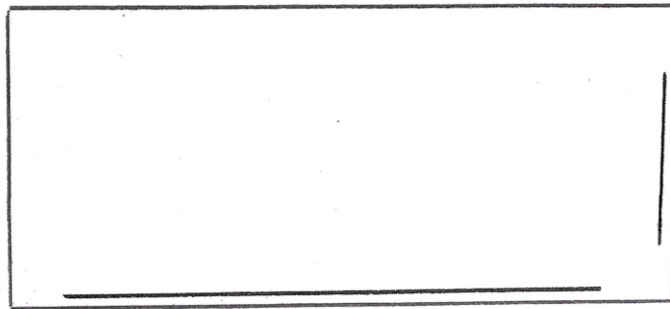
Unit: 503

- Shutter
- Newer SGD's (Both) Vinyl -missing push plugs,
Perimeter Sealant open/missing
- Seal Light /receptacle

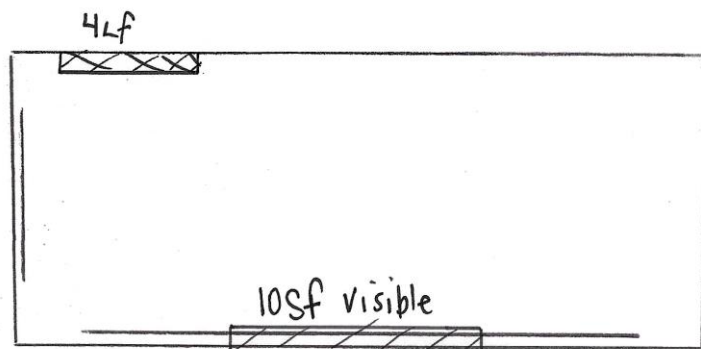
Sand Dollar IV
Unit: 504

- Shutter
- Original SGD's - holes in threshold
- Seal light/receptacle
- Replace LR Slider / MBR - is serviceable
- Corroded conduit fasteners
-
-

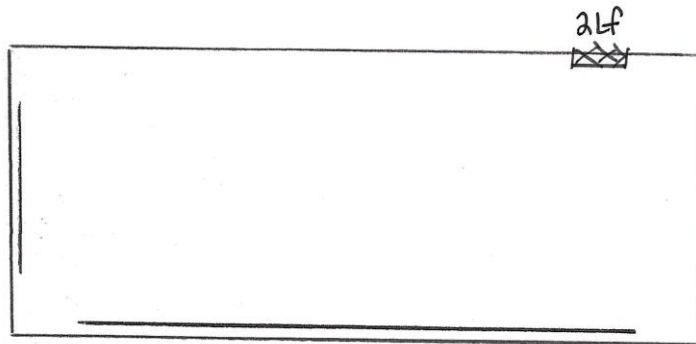
Sand Dollar IV
Unit: 506

SGD's Wet zone unsealed

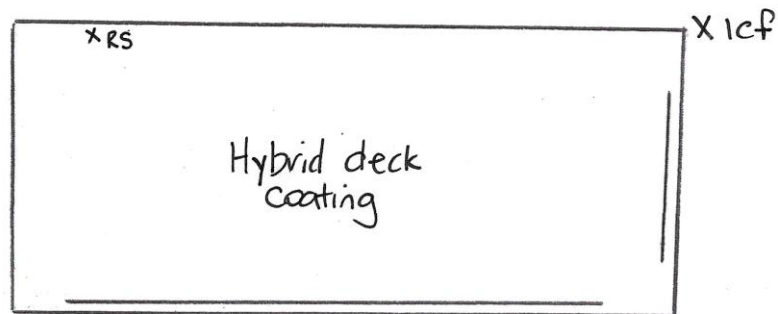
Unit: 507

Seal wet zone SGD MBR

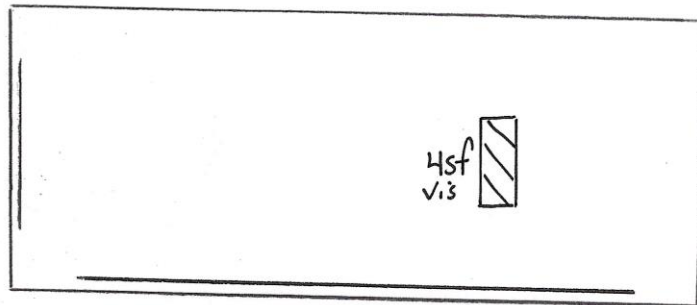
Unit: 508

Seal tight / receptacle

Newer PGT SGD's - wet zone unsealed
missing Sealant around doors

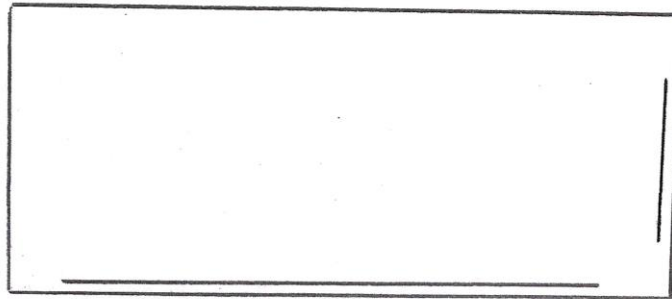
Unit: 401

Seal Light/receptacle

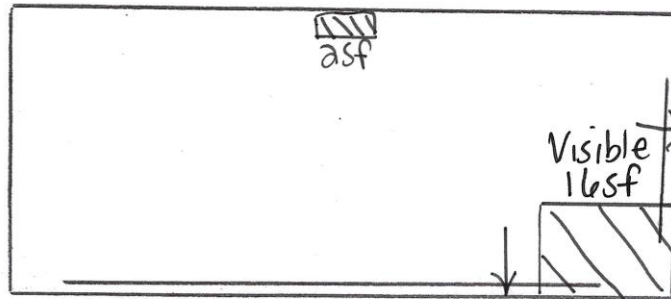
Unit: 403

Seal wet zone & Around SGD's

Cracked tile inside

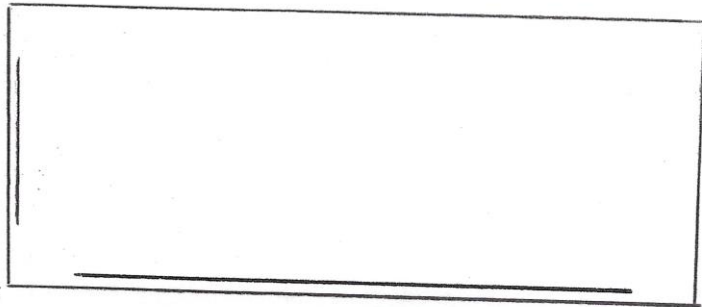
Sand Dollar IV
Unit: 404

Original
SGD
holes in →
threshold
recommend
replacement

Seal wet zone on LR SGD

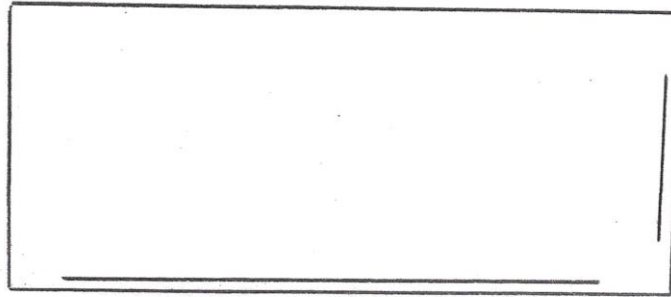
Unit: 405

Seal Light / Receptacle

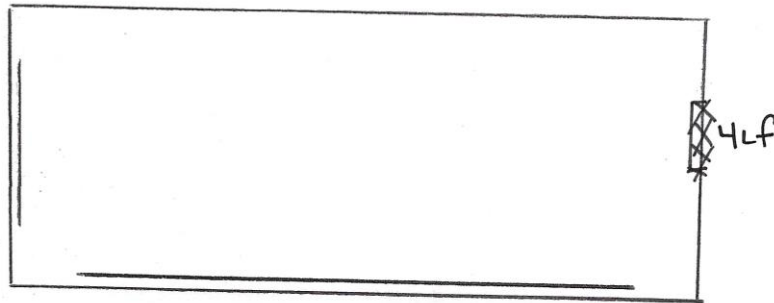
Unit: 408

Aluminum SGD's wet zone unsealed and
missing fasteners

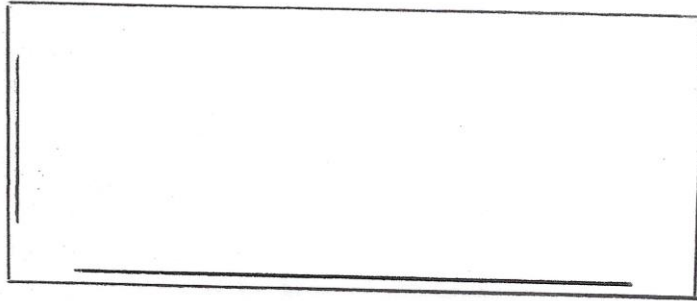
Unit: 302

SGD's Vinyl Silicone Around doors - LR Window - Window World
Light /receptacle not Sealed

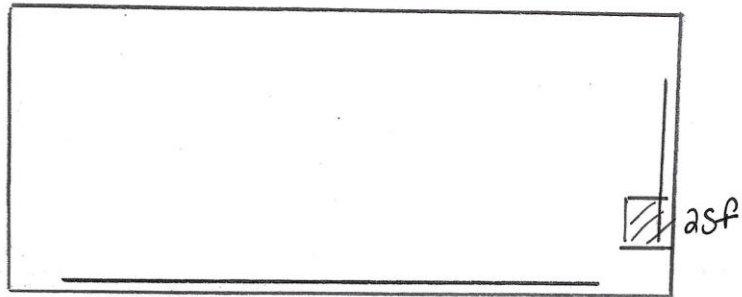
Sand Dollar IV
Unit: 303

Newer Vinyl SGD's wet zone unsealed

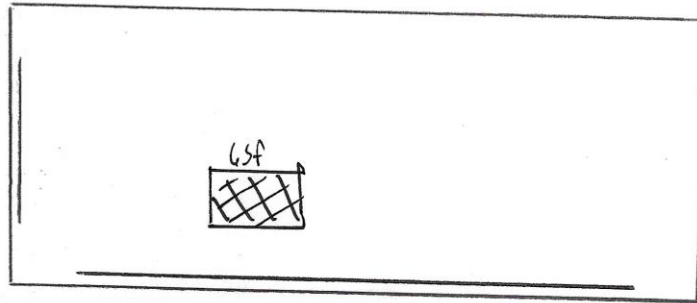
Unit: 306

SGD's original wet zone not sealed

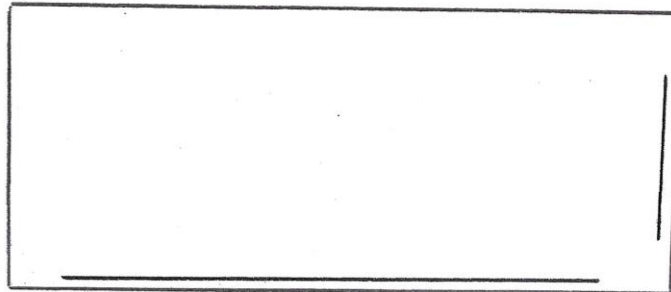
sand Dollar IV
Unit: 307

Original SGD's holes in threshold + wet zone
unsealed

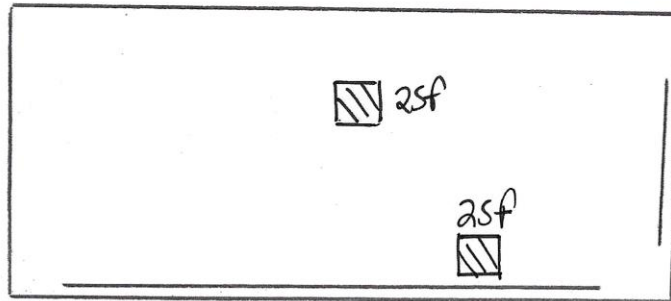
Sand Dollar IV
Unit: 201

SGD's Aluminum - Wet zone unsealed

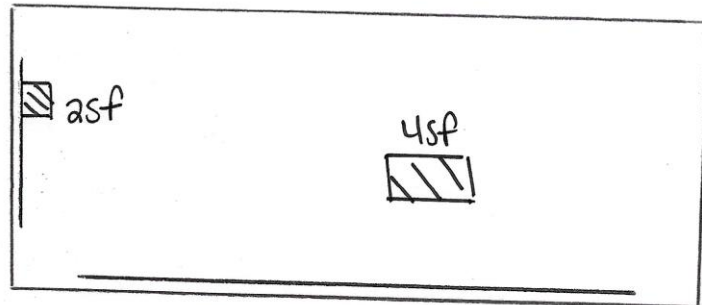
Sand Dollar IV
Unit: 202

SGD's Vinyl Appear LR wall has water
intrusion (Drywall out)

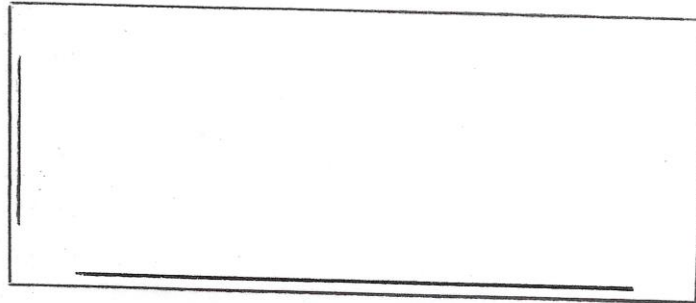
Sand Dollar IV
Unit: 204

SGD - Vinyl Missing Push Plugs / Perimeter Sealant
Window LB Vinyl Missing Push Plugs / Perimeter Sealant

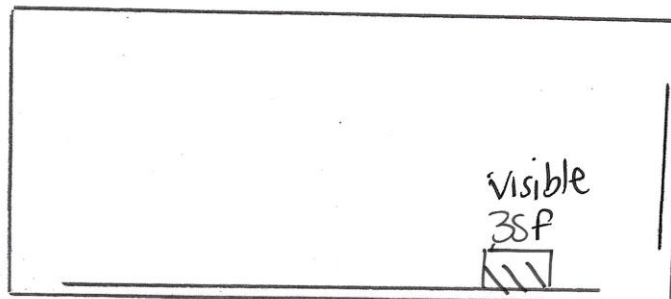
Sand Dollar IV
Unit: 205

Original SGD's Wet zone unsealed - both
thresholds are oxidized and have holes

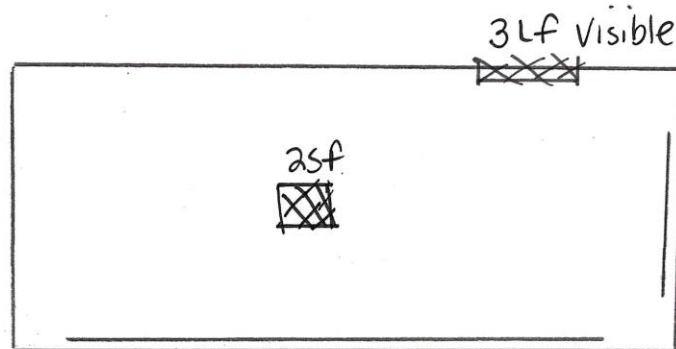
Sand Dollar IV
Unit: 101

Tile on deck
original SGD's wet zone unsealed

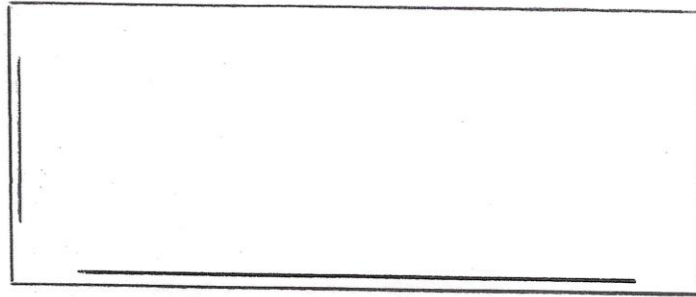
Sand Dollar IV
Unit: 102

original SGD's wet zone unsealed
(Bedroom Slider has holes in threshold)
